UM Western Matthews Hall Bathrooms Study

Project: UM Western Matthews Hall Bathrooms Study
Location: **UM Western Campus**, Dillon, Montana
Owner: **State of Montana**
Architect: **Mosaic Architecture, P.C.**, 428 No. Last Chance Gulch, Helena, MT

Project Phase Submittal: Feasibility Study

UM Western - Mathews Hall Bathrooms Renovation Facilities Study

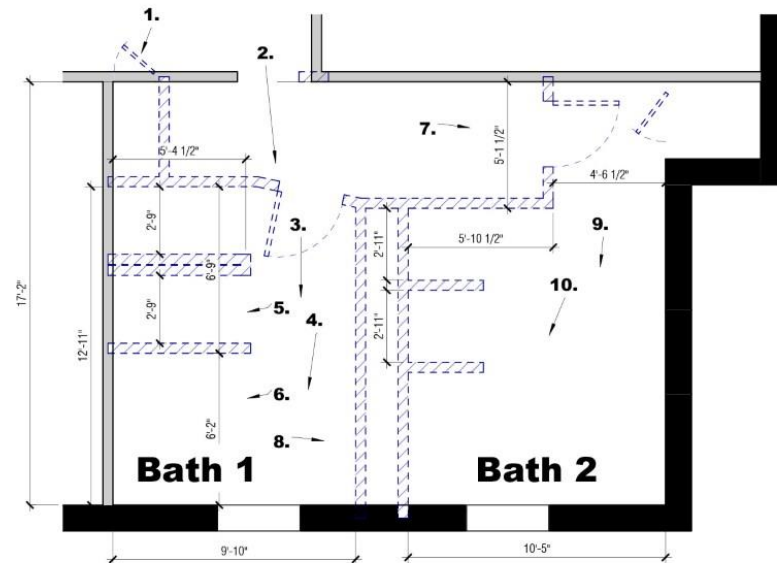
1 LEVEL 2 & 3 - EAST
1/4" = 1'-0"

1. JANITOR CLOSET

2. ENTRY TO BATHROOM 1 - Inappropriate venting from bathroom

3. BATHROOM SINK - dated fixtures and casework: Not ADA compliant

4. TOILET/SINK AREA

5. SHOWER

6. TOILET PARTITIONS

7. ENTRY TO BATHROOM 2

8. SINK AREA

9. BATHROOM 2

10. SHOWER AREA

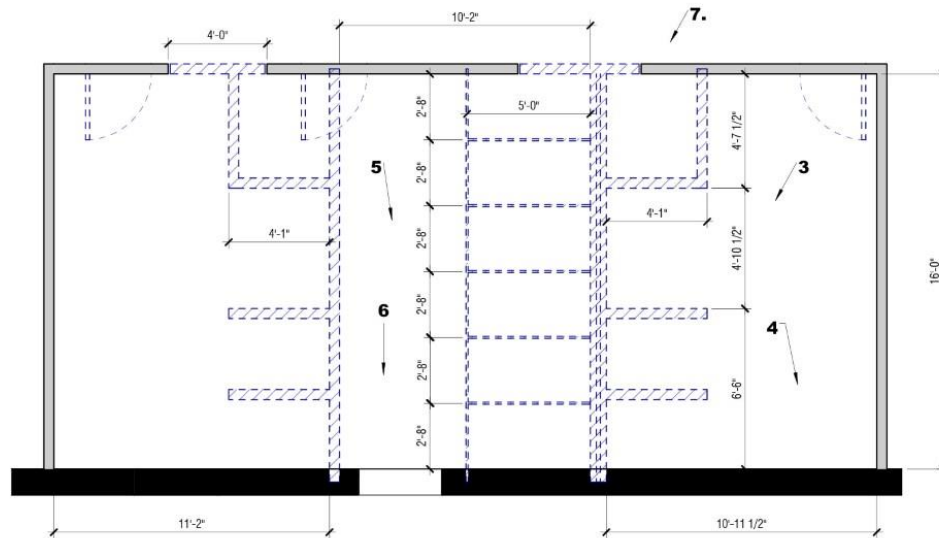
2 LEVEL 3 & 4 - MID
1/4" = 1'-0"

1. FIRE EXIT THROUGH BATHROOM AT 3RD FLOOR

2. FIRE EXIT THROUGH BATHROOM AT 3RD FLOOR

3. SHOWERS & TUB

4. DIRECT VENT TO OUTSIDE - No lower or closure

5. TOILET STALLS & LIGHT FIXTURE - Exposed lamp at light fixture

6. WINDOW AND VENTING - Single pane glazing and inappropriate venting

7. SMALL JANITOR CLOSET

8. SHOWER AREA

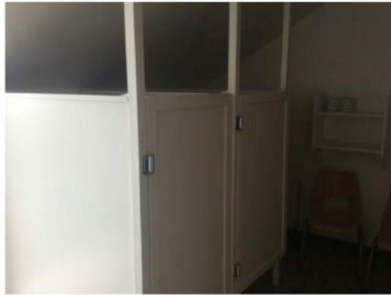
1. SHOWER and TOILETS UNDER SLOPE - May be code non-compliant for ceiling height

2. SHOWER

1. WINDOW DORMER

4. TOILET PARTITIONS UNDER SLOPE

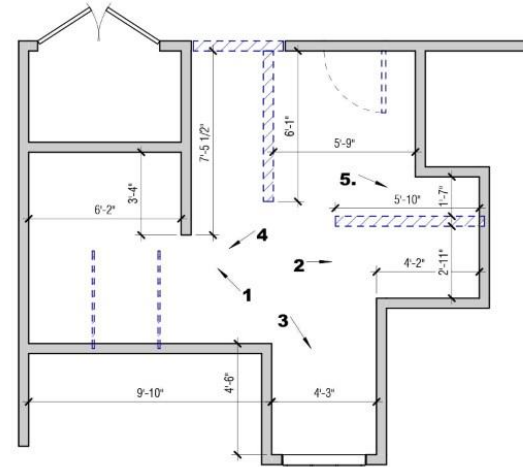
5. SINK - Tight space

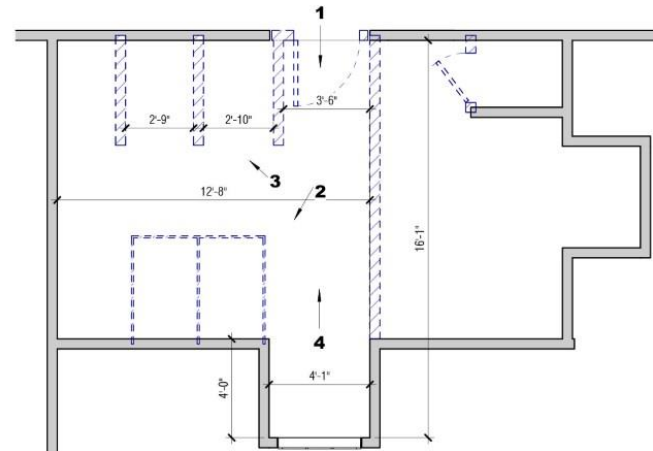
1 EXISTING EAST BATHROOM - LEVEL 4
1/4" = 1'-0"

1. FROM BATHROOM ENTRY - Exposed lamp on light fixture; tight space at entry, dated finishes and fixtures

2. TOILET PARTITIONS

3. SHOWER AREA

4. LOOK BACK TO ENTRY - Inappropriate venting into the hall
